GEMTEC LIMITED
GROUND ENGINEERING
& MATERIALS TECHNOLOGY

**RE: ENVIRONMENTAL SOIL INVESTIGATION
BELLEDUNE AREA, NEW BRUNSWICK**

The following is a summary report of the sampling work that was undertaken at several areas of concern in the Belledune region. The work was completed between November 26th and December 3rd, 2003.

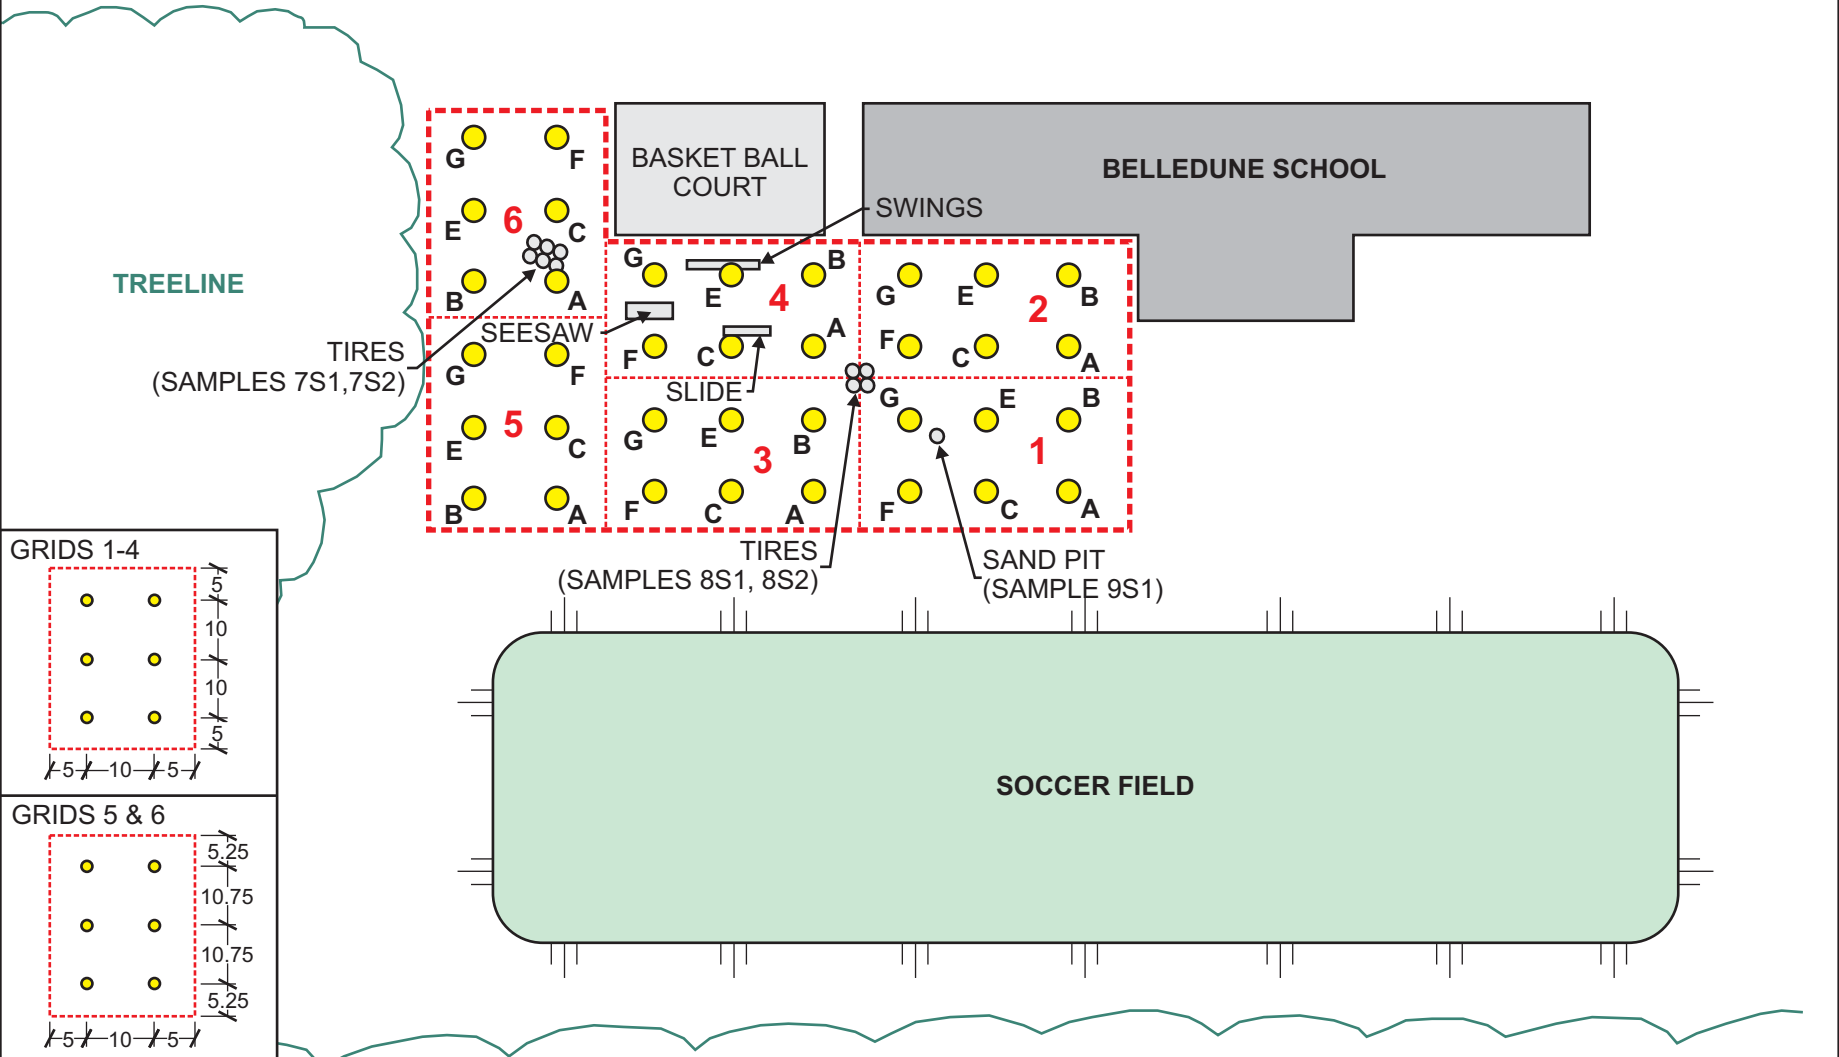
Drawn By AGSD	Date DEC., 2003	File No. 37820404	Drawing No. FIGURE 2	Revision No. 0
------------------	--------------------	----------------------	-------------------------	-------------------

Area 1 Belledune School Playground (refer to Figure 2)

- School is located on the south side of Route 134.
- Property facilities generally consist of school, two paved basketball courts (one on each side of school), playground area (west side), driveways and parking (front of school), and a soccer field (south side or behind the school).
- The land is generally flat, although the soccer field is elevated approximately 1.5 m above the surrounding area.
- Except for paved areas, the site is grass covered.
- The playground area, west of the school, consists of swing sets, slides, teeter-totters, and old tires used as climbing apparatus. The area around the tires has been fenced off with orange snow fence.

- To the east, west and south the adjacent properties are lightly wooded.
- The school well is located near the highway on the northwest corner of the site.

Note: Local testimony (a municipal office worker) indicated that the areas fenced off on the site were the locations where the soils tests by others indicated high levels of lead).

- Arsenic levels in the soils on the playground property range from 10 to 14 parts per million (ppm), slightly exceeding the CCME guideline of 12 ppm.
- Lead levels in the soils of the playground area range from approximately 42 to 106 ppm. In the soils around the tires and in the sand pit area, however, lead concentrations were found to exceed the CCME guideline of 140 ppm. This is quite likely due to the past use of lead paint on the playground equipment and/or from sand imported to the site (sandbox area). Samples of flaking paint, taken from the tires, contained lead at levels of 195 and 313 ppm. It is important to note that the sand pit area is small compared to the total playground area.
- Lead concentrations in dust wipe samples taken from inside the Belledune School were all below US EPA Guidelines (sample locations shown in Figure 7).

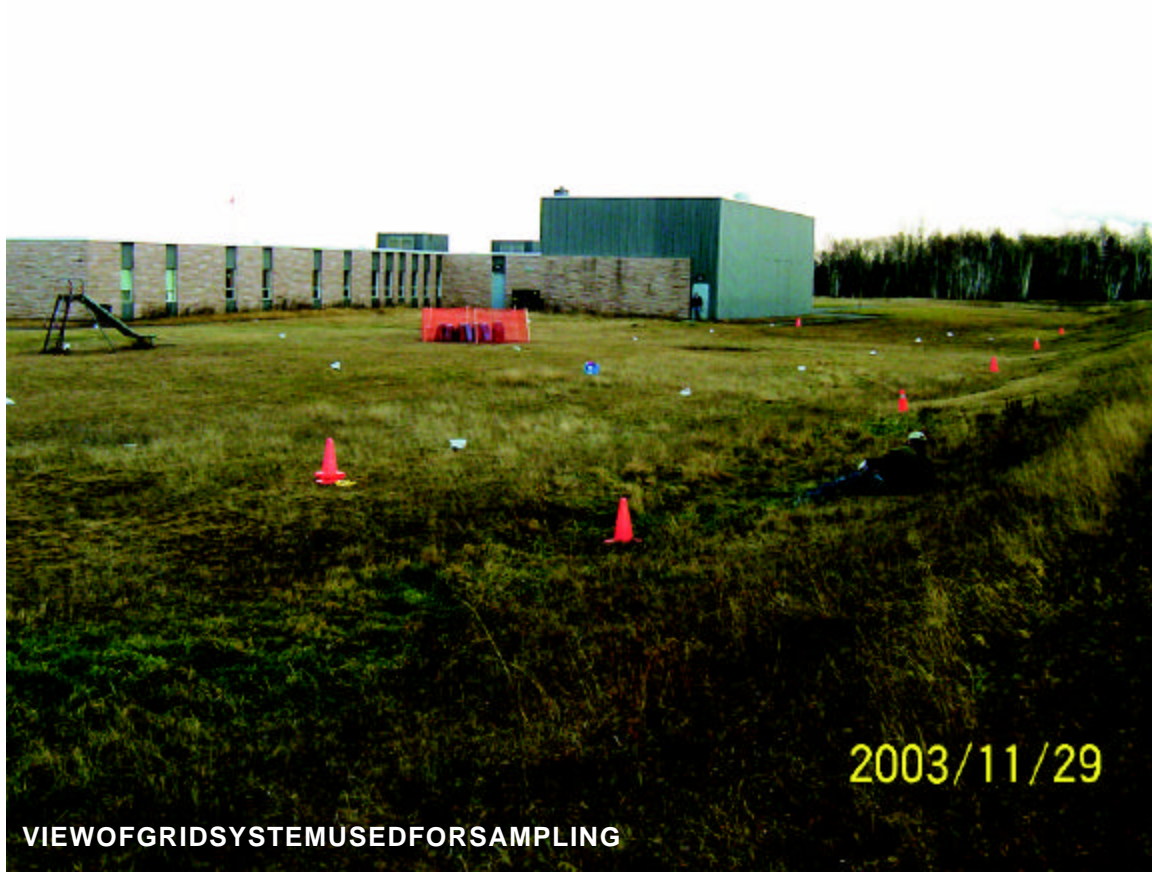
VIEW OF GRID SYSTEM USED FOR SAMPLING

- **Composite soil samples** were collected at the Belledune School and the Townsite #2 ball field following the US EPA protocol (Soil Screening Guidance: Technical Background Document EPA 1996). Following this methodology, soil specimens are taken from a systematic grid-sampling scheme covering an exposure area. Thirty-six soil specimens are blended and reduced to six representative soil samples for each exposure area. These samples are meant to provide representative concentrations of chemicals of concern (in this case metals) across the exposure area.
- **Grab samples** were collected at the Roherty Point beach and bus stop locations, because the exposure areas were not well defined. A grab sample is defined as a single sample collected at a particular time and place that represents the composition of the media only at that time and place. Grab samples are typically

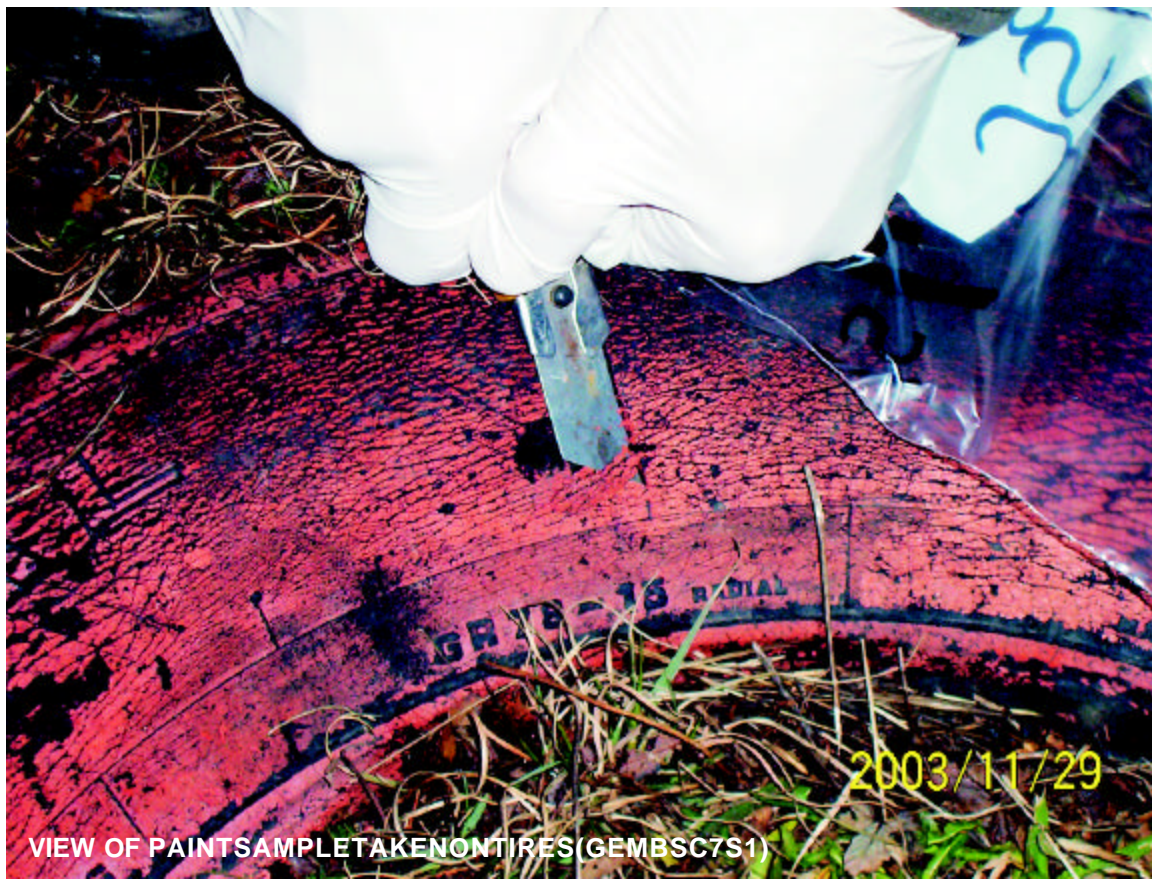
VIEW OF PAINT SAMPLE TAKEN ON TIRES (GEMBSC7S1)

Sample ID	Location/type	Sample Date	Arsenic mg/kg	Cadmium mg/kg	Lead Concentration
GEMRBS8	Metal pieces on Roherty Beach	11/29/03	< 10	< 1	> 98 %
Duplicate*	Lab internal QA/QC		160	< 1	> 98 %
GEMBSC7S1	Paint from tires - W (school)	11/29/03	4	3.8	195 mg/kg
GEMBSC8S2	Paint from tires - E (school)	11/29/03	4	2.4	313 mg/kg

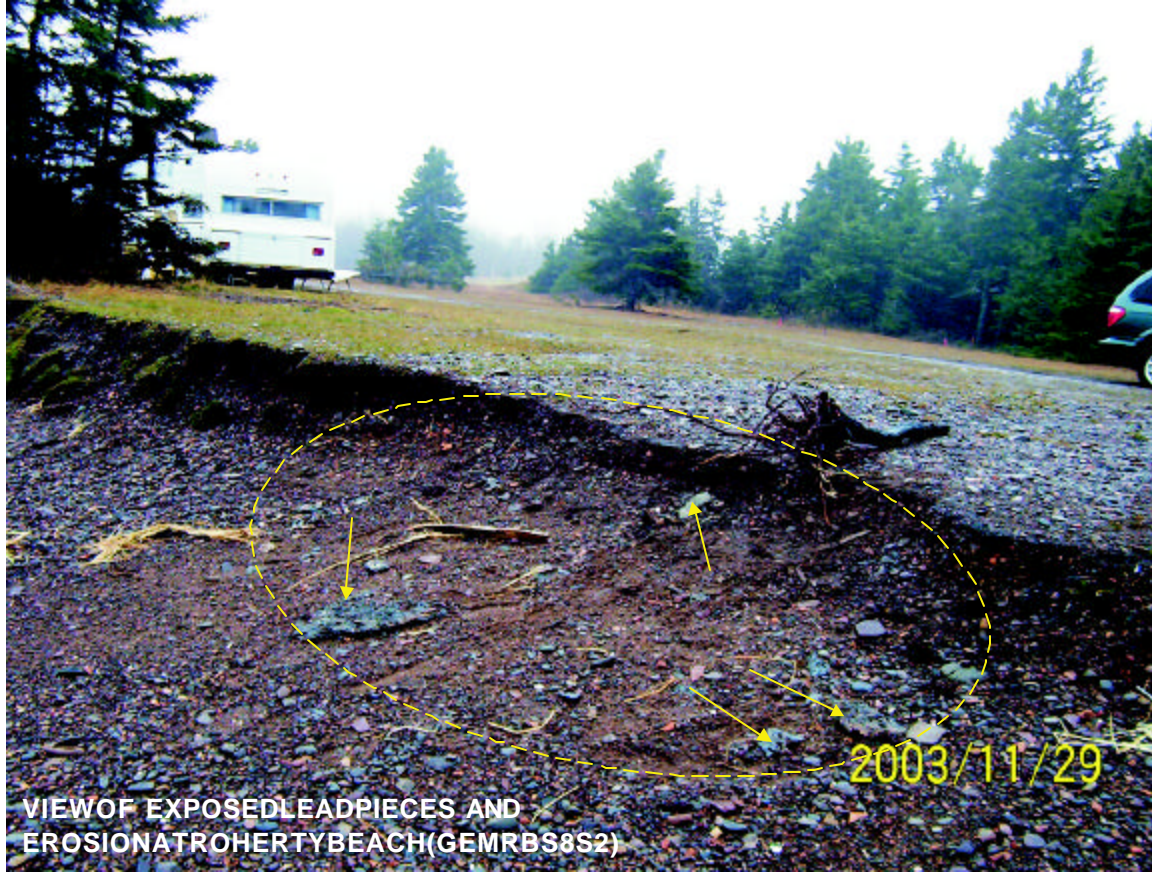
VIEW OF EXPOSED LEAD PIECES AND
EROSION AT ROBERTY BEACH (GEMRBS8S2)

- All lead and arsenic levels in samples obtained at Roherty Point were below CCME guidelines, with the exception of one sample (Sample S5) taken below the vegetation mat in an area where scattered debris was observed.
- Metal debris found on the beach (Sample S8) contained 98 percent lead.

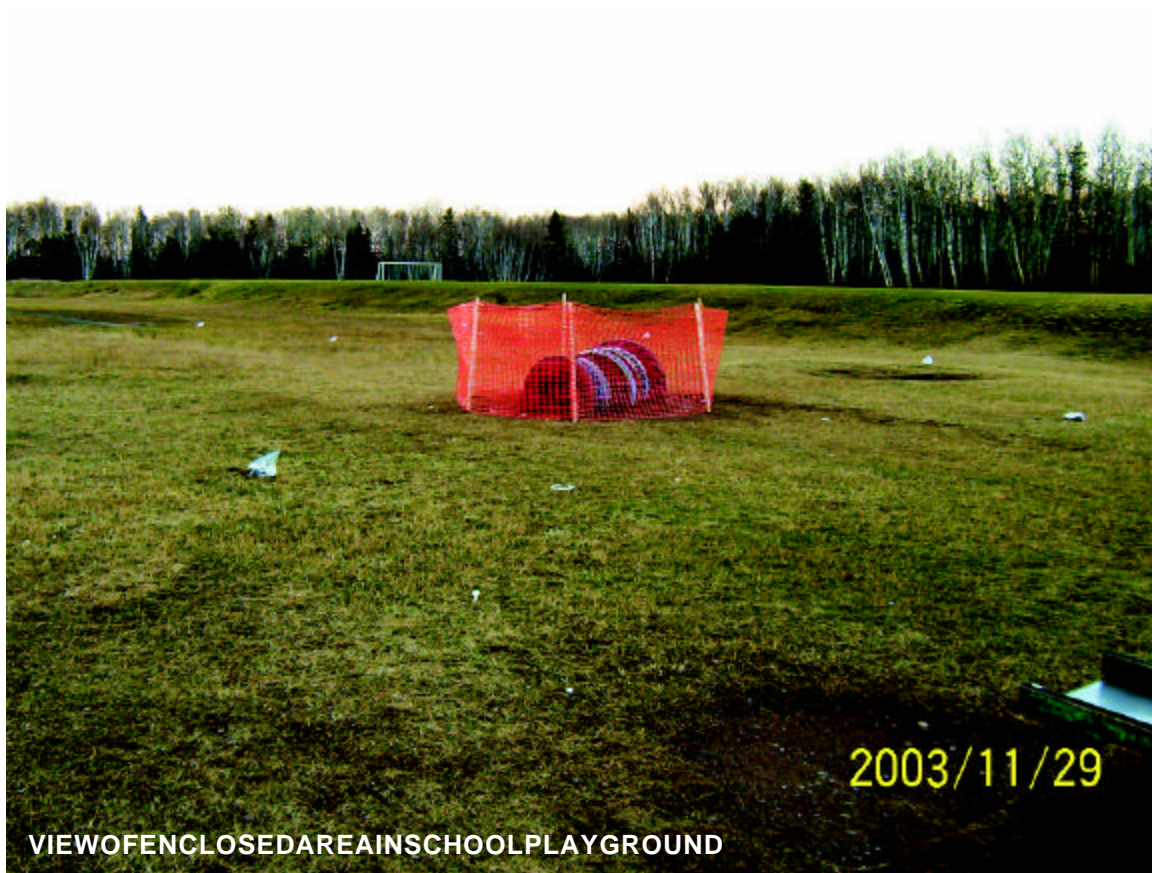
VIEW OF ENCLOSED AREA IN SCHOOL PLAYGROUND
